Manhole Inspection Summary

Manhole # S43K2_007MH

Insp Date: **1/7/08 8:20 AM**

Location Address: **1055 Church St**

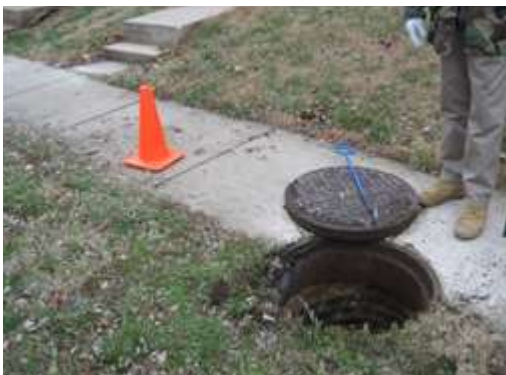
Location View

1057 church st

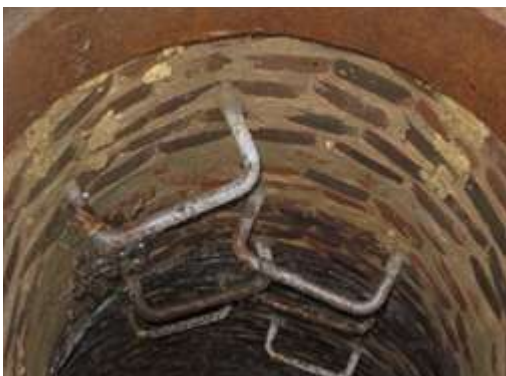
steps

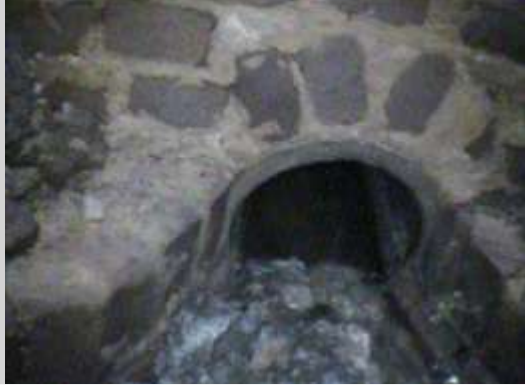
12 O'Clock Outflow

8 in. Circular Gravity Sewer
Pipe Out @ 12 O'Clock

Pipe Height: **7.2** (in.) Rod and Bar (Angled)
Pipe Material: **Clay** ☐ Pipe Lined
Invert Depth: **12.28** (ft.) Flow Characteristics: **Fast**
Deposits: ☒ None ☐ Mud ☐ Sludge ☐ Debris ☐ Grease
Silt Depth: (in.) Deposits Extent:
Infiltration: **None** Pipe Seal Cond: **Sound**

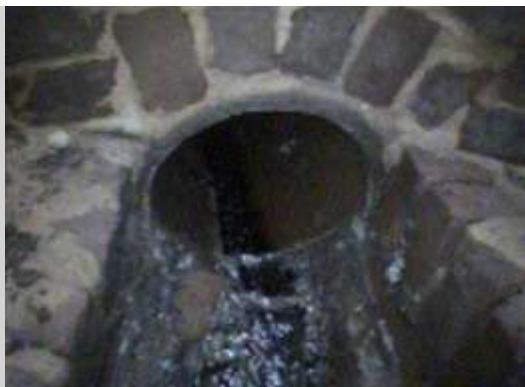
3 O'Clock Inflow

8 in. Circular Gravity Sewer
Pipe In @ 3 O'Clock

Pipe Height: **6** (in.) Rod and Bar (Angled)
Pipe Material: **Clay** ☐ Pipe Lined
Invert Depth: **11.78** (ft.) Flow Characteristics: **Fast**
Deposits: ☒ None ☐ Mud ☐ Sludge ☐ Debris ☐ Grease
Silt Depth: (in.) Deposits Extent:
Infiltration: **None** Pipe Seal Cond: **Sound**

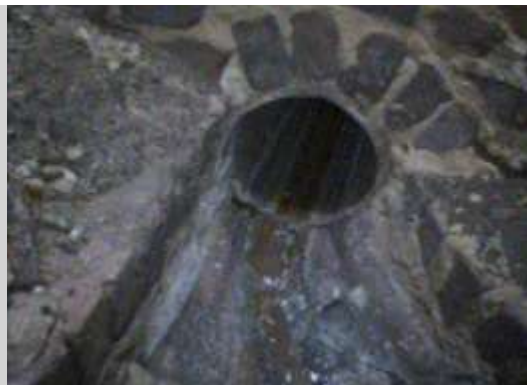
6 O'Clock Inflow

8 in. Circular Gravity Sewer

Pipe In @ 6 O'Clock

Pipe Height: **7.2** (in.) Rod and Bar (Angled)

Infiltration: **None** Pipe Seal Cond: **Sound**
